**2008 Historic Resource Survey  
North Side, City of Granbury**

**Property No.: 134  
703 East Moore**

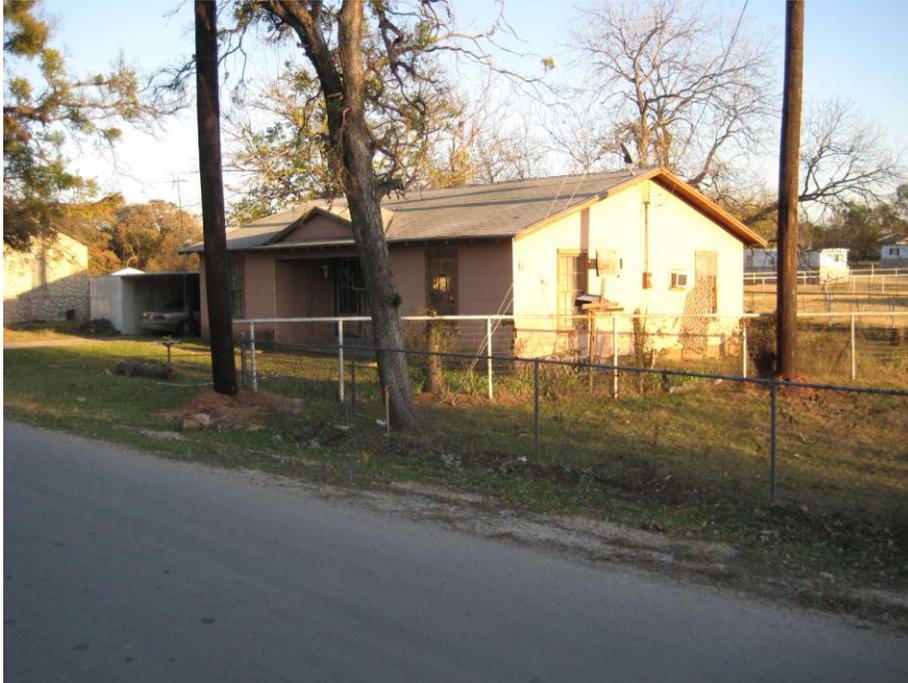
Frame construction, asbestos siding  
Gable roof, composition shingles  
Double-hung, aluminum and wood windows, 6/6  
Single-door primary entrance  
Gable roof porch, fabricated metal supports  
Center passage plan  
Pier and beam foundation  
One story, 1,070 square feet  
Shed/porch addition to east side of house

**Location, setting, feeling**

**Neglect**
