2008 Historic Resource Survey
North Side, City of Granbury
Property No.: 137
719 East Moore

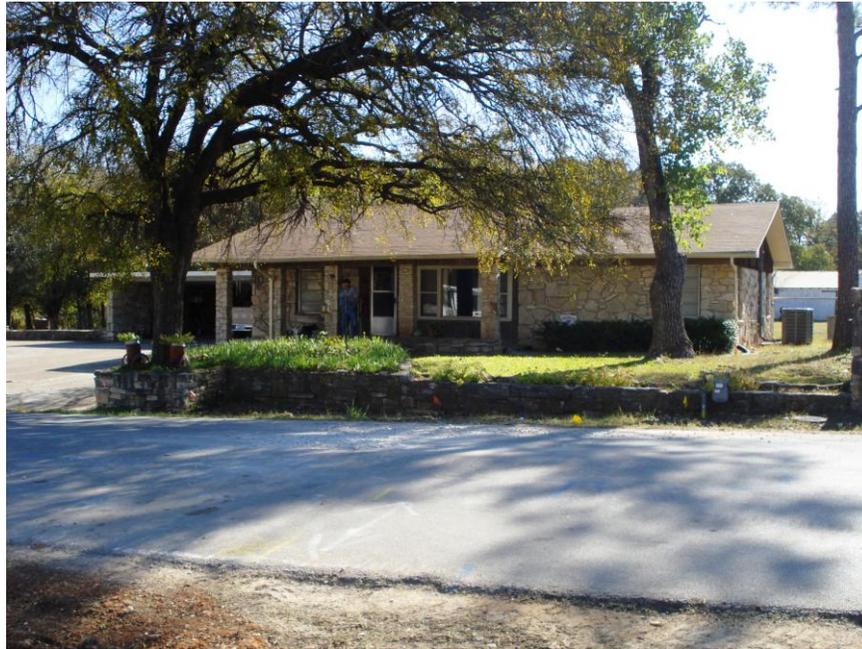
Frame construction, limestone veneer
Gable roof, composition shingles
Double-hung and fixed, aluminum windows
Single door primary entrance
Hipped roof porch, box columns with limestone veneers
Rectangular plan
Pier and beam foundation
One story, 1,786 square feet
Limestone wall with old grindstone embedded in east side of west wall

Location, workmanship, setting, feeling, association
