Site #105

**511 N. Travis**  
Granbury  
Hood County  
Est. 1910

**Property Type:** Vernacular House

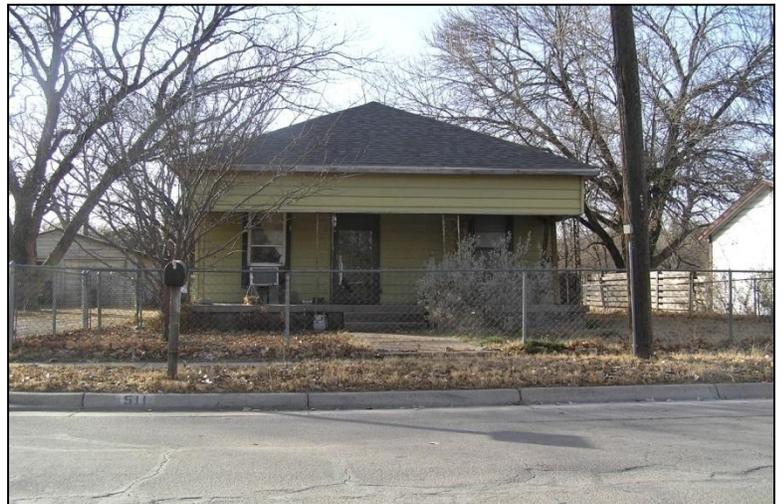
**Photo Data:** Roll/Frame G1/3

- Building faces east
- One story frame structure
- Bungalow plan
- Pier and Beam foundation
- Three bay, east elevation inset porch with fabricated metal supports
- Aluminum sash, double hung windows
- Hipped roof
- Old building that has been altered

**Outbuildings:** Old cellar out back
