Site #123

125 S. Travis
Granbury
Hood County
Est. 1910

Property Type: Vernacular House

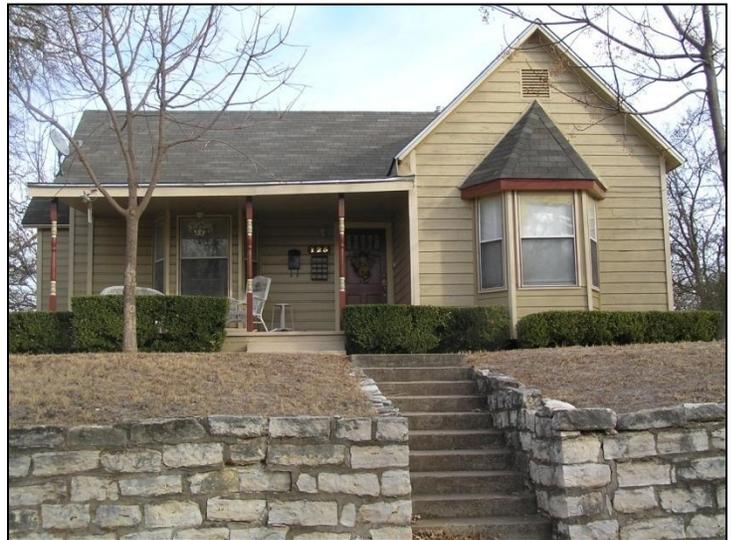
Photo Data: Roll/Frame G1/23

Areas of Significance (include justification): Inappropriate alterations may be reversible

-Building faces west

-One story frame structure

-L-plan

-Pier and beam foundation

-Weatherboard siding

-Four bay, west elevation porch with shed roof and turned wood posts

-Aluminum sash, double hung/casement windows

-Single door primary entrance

-Gable end treatments same as wall surface

-Gable roof with composition shingles

-Bay window in front
