Site #19

**615 W. Bluff**

Granbury  
Hood County  
Est. 1950

**Property Type:** Vernacular House

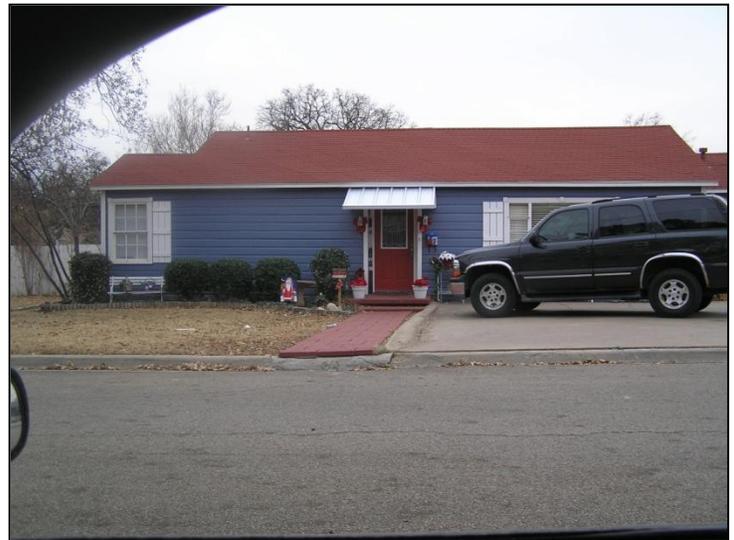
**Photo Data:** Roll/Frame D2/13

Location: Original Location

- Building faces North
- Frame Construction
- Bungalow Plan
- Pier and Beam and Cement Foundation
- Weatherboard Siding on Exterior Wall Surface
- One inset porch
- Wood sash, casement windows (Six over Six)
- Single door primary entrance with decorative screen door
- Gable End Treatments same as wall surface with vents
- Gable roof
- Composition shingles with exposed rafter ends
