Site #21

**521 W. Bluff**

Granbury  
Hood County  
Est. 1945

**Property Type:** Vernacular House

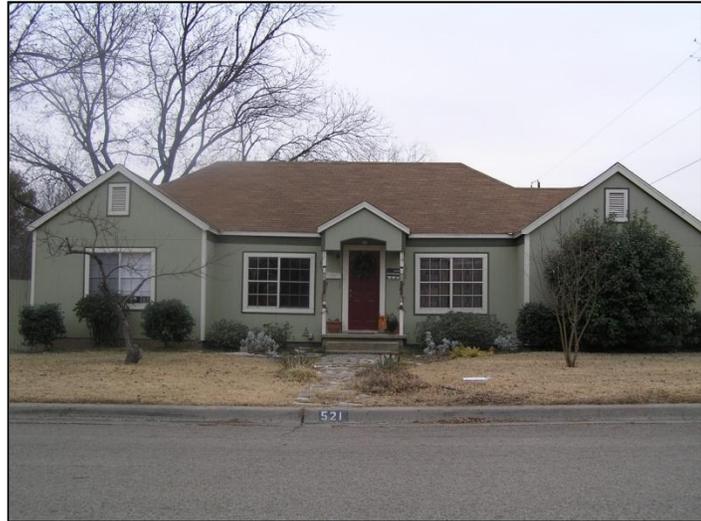
**Photo Data:** Roll/Frame D2/15

-Building faces north

-Frame House

-Center Passage Plan

-Pier and Beam and Cement Foundation

-Weatherboard Exterior Siding

-One north elevation gable roof porch with turned-wood posts

-Aluminum sash, double hung windows (Six over Six)

-Single door primary entrance

-Gable End Treatments same as wall surface with vents

-Composition shingled roof with box eaves
