Site #104

116 N. Thrash

Granbury

Property Type: Vernacular House

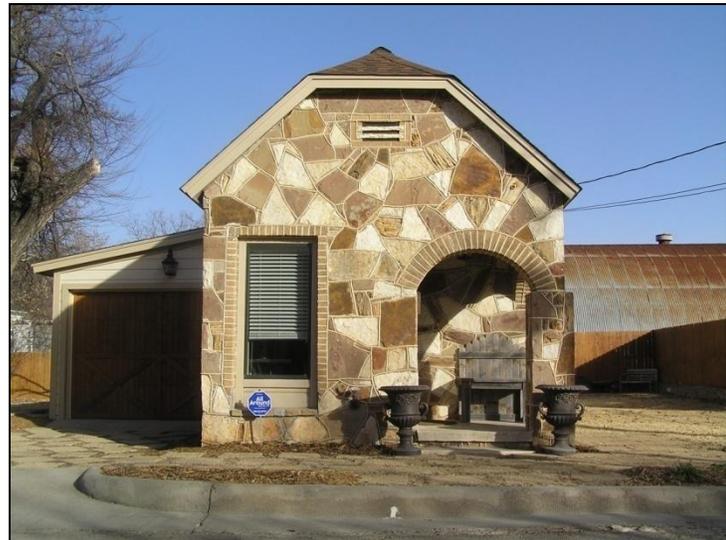
Photo Data: Roll/Frame M4/16

Description of Building:

-Building faces west

-One story, solid stone structure

-Center passage plan, four rooms deep

-Pier and beam foundation

-Stone, mixed with petrified wood and beaded mortar exterior wall surface

-One bay, west and south elevation inset porch with stone box columns and arches trimmed with brick

-Wood sash, double hung windows in back (1/1), Fixed, one light window in front

-Single door primary entrance

-Gable end treatments same as wall surface, with vents (capped gable with roof)

-Gable roof with composition shingles

-Two wooden additions, one in back and one on north side
