Site #132

**213 S. Lambert**

Granbury

**Property Type:** Vernacular House

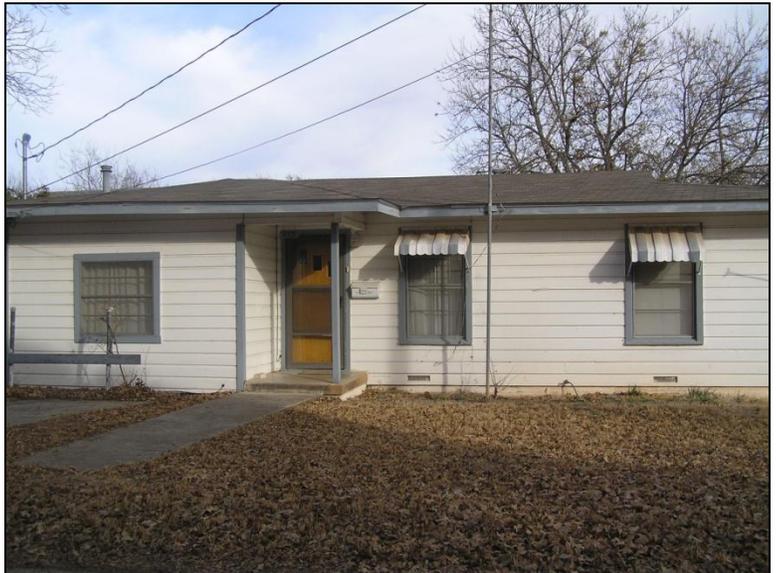
**Photo Data:** Roll/Frame M6/3

Location: Original Location

-Building faces west

-One story frame structure

-Center passage plan (two rooms deep)

-Pier and beam foundation

-Weatherboard siding

-One bay, west elevation, inset porch with hipped roof and square posts

-Aluminum sash, double hung windows (2/2 horizontal)

-Single door primary entrance

-Hipped roof with composition shingles
